# XMM-Newton MOS1 Micrometeorite Event

E.Serpell  
ESA / ESOC / VEGA  
11/10/01

# Event Summary

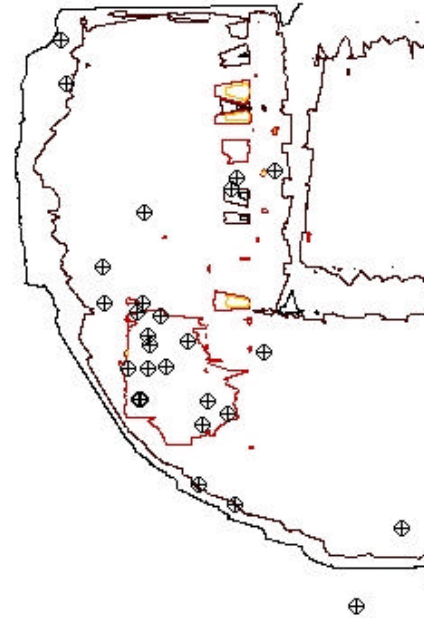
# CCD Damage

- The figure shows the distribution of new bad pixels overlaid with a contour of  $E1+E2$ .
- In exposures following the event 27 bad pixels appeared on CCD6 and CCD7.
- The new bad pixels coincide with the location where the energy was greatest.
